# The Linenhall

**TDS TECH4100 Assessment 1  
Collaborative Project**

**Survey Site Address:** TU Dublin Linenhall, Henrietta Place,  
Dublin 1

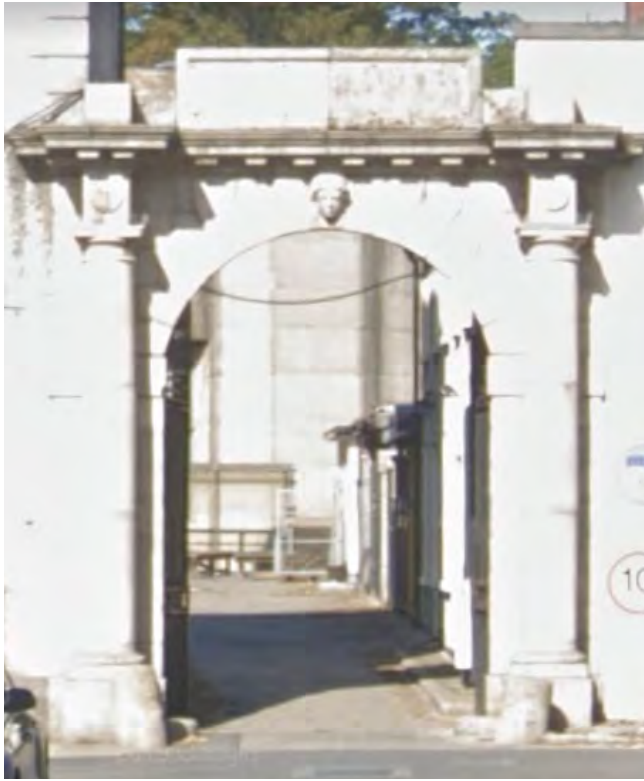
Archway to TU Dublin College

“This well-executed carriage arch, designed by Thomas Cooley, provides an interesting architectural and artistic element on the streetscape. It was formerly the entrance to the City Linenhall and Yarnhall, built for the storage of yarn and linen in the city”

“Round-headed arch, built c.1781, opening from TU Dublin college to Yarnhall Street and Henrietta Place. Cut granite walling with rectangular fascia and with moulded surround to top. Granite Tuscan columns on square plinth bases having square capitals with blocking course having round bosses supporting moulded dentillated granite projecting cornice. Rusticated gauged granite voussoirs to arch, moulded bust to keystone. Roughcast rendered wall to rear of arch. Double-leaf cast-iron gate with decorative upper part. Granite wheel-guards flanking entrance.”

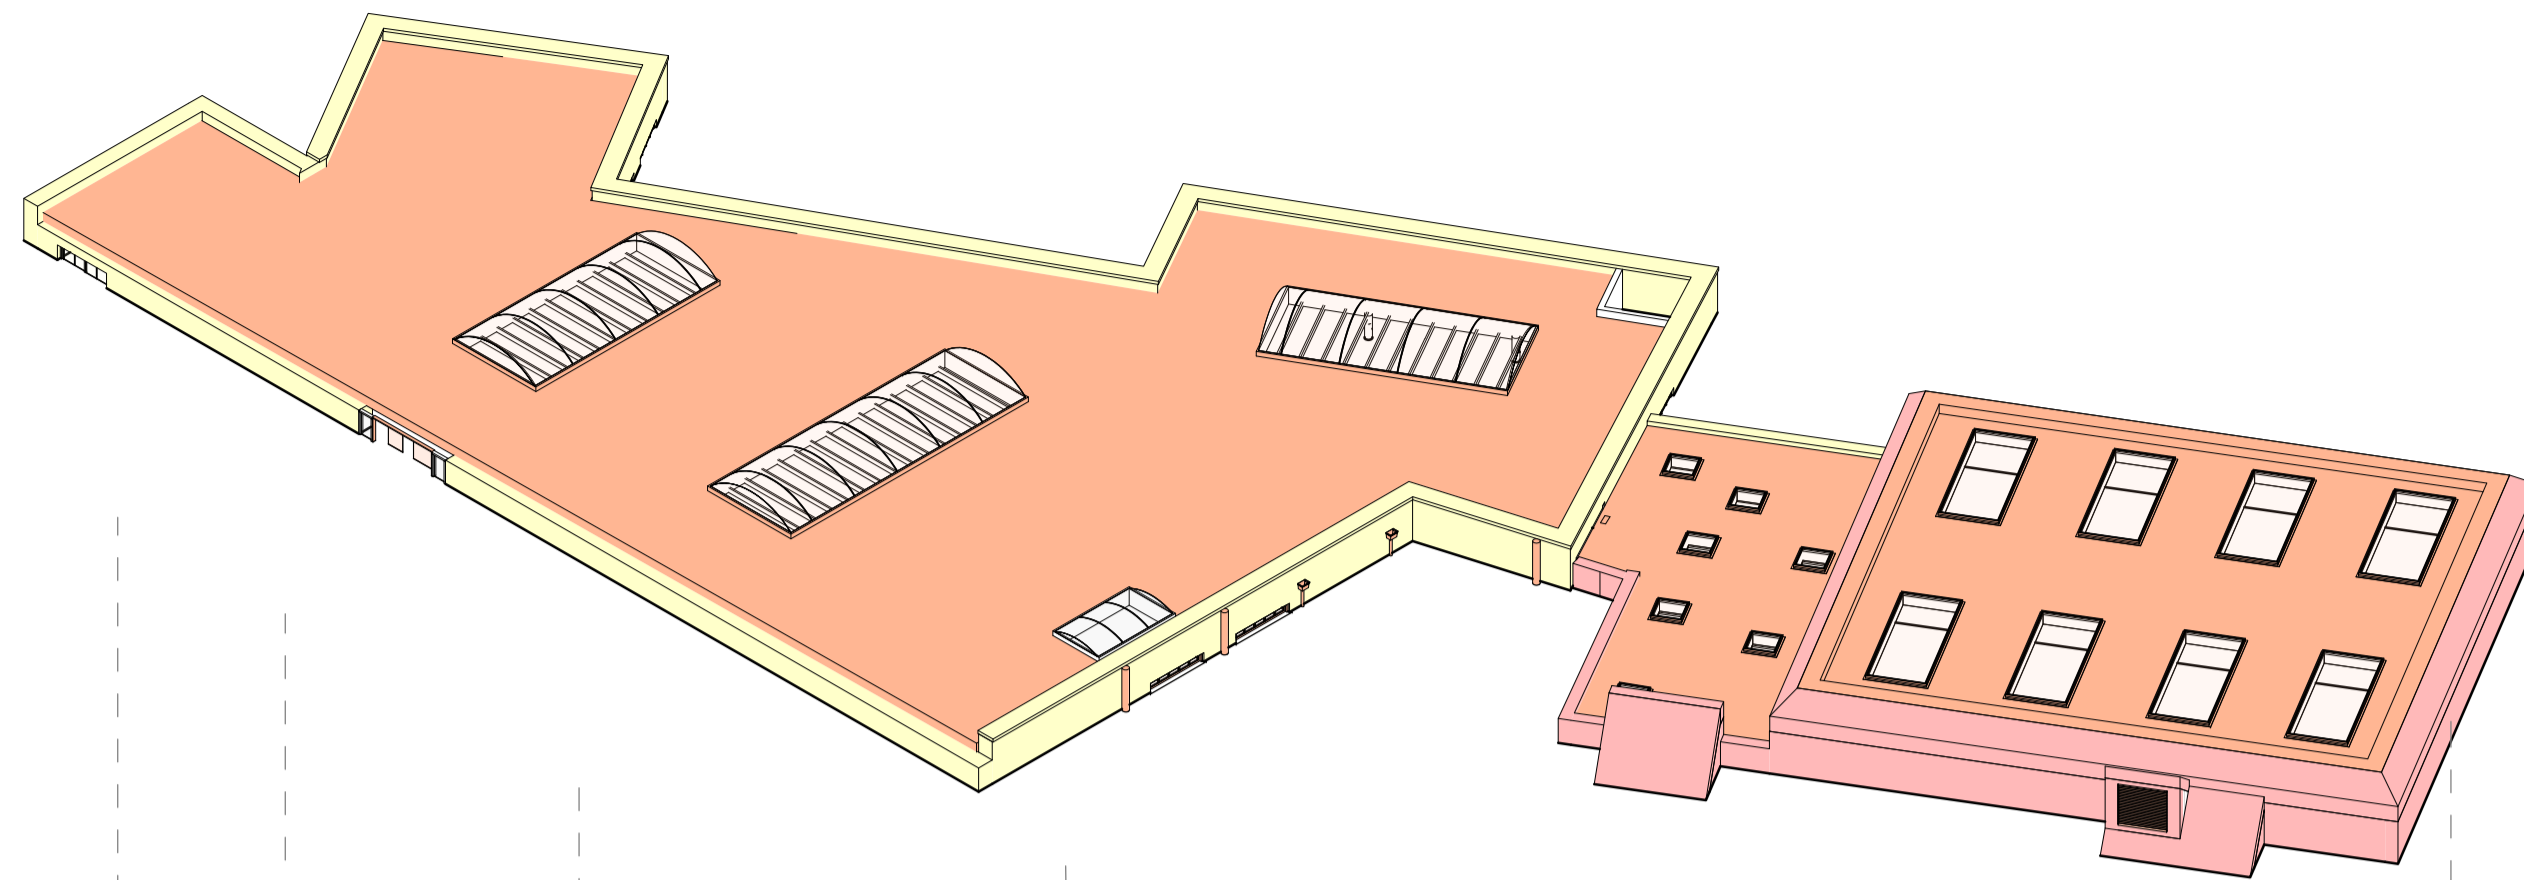
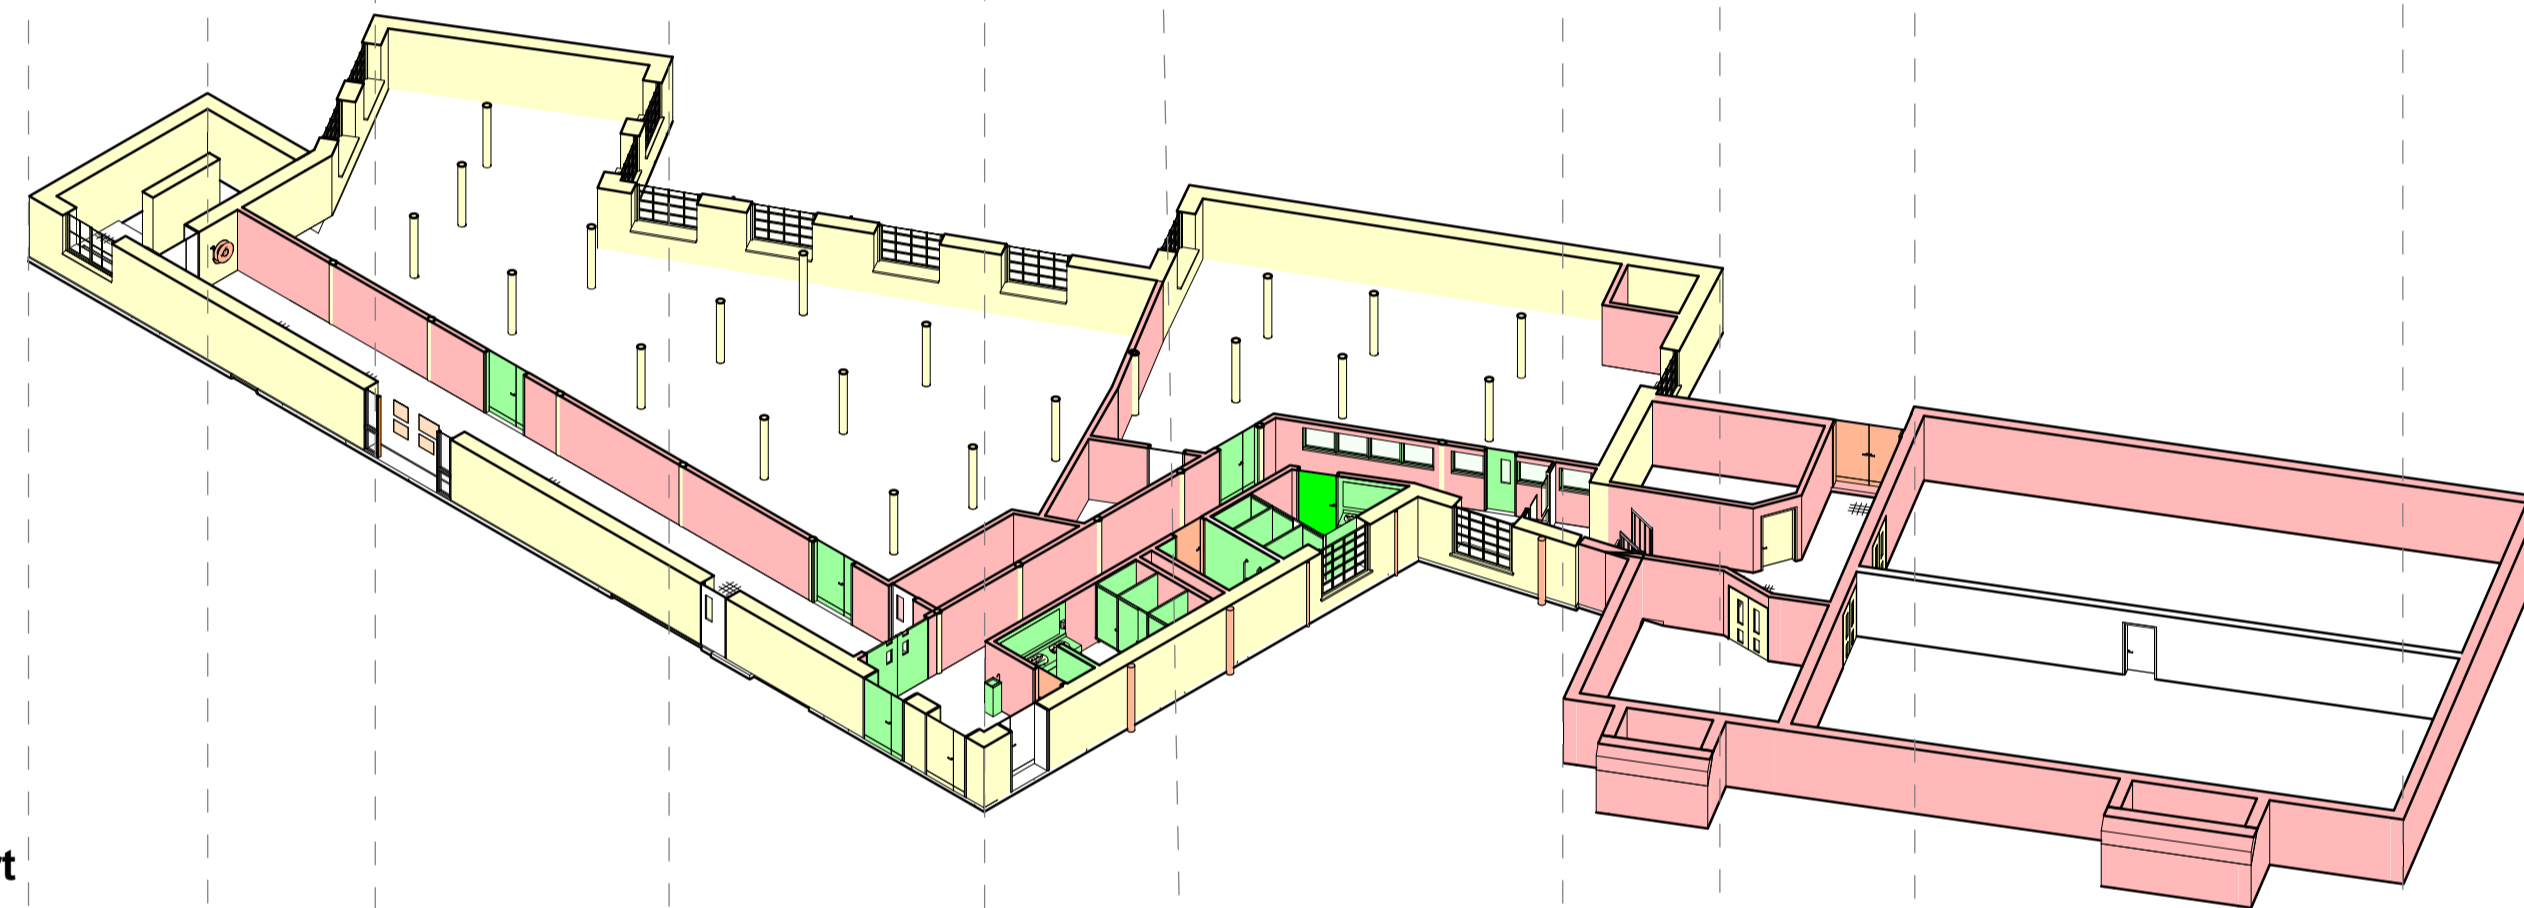
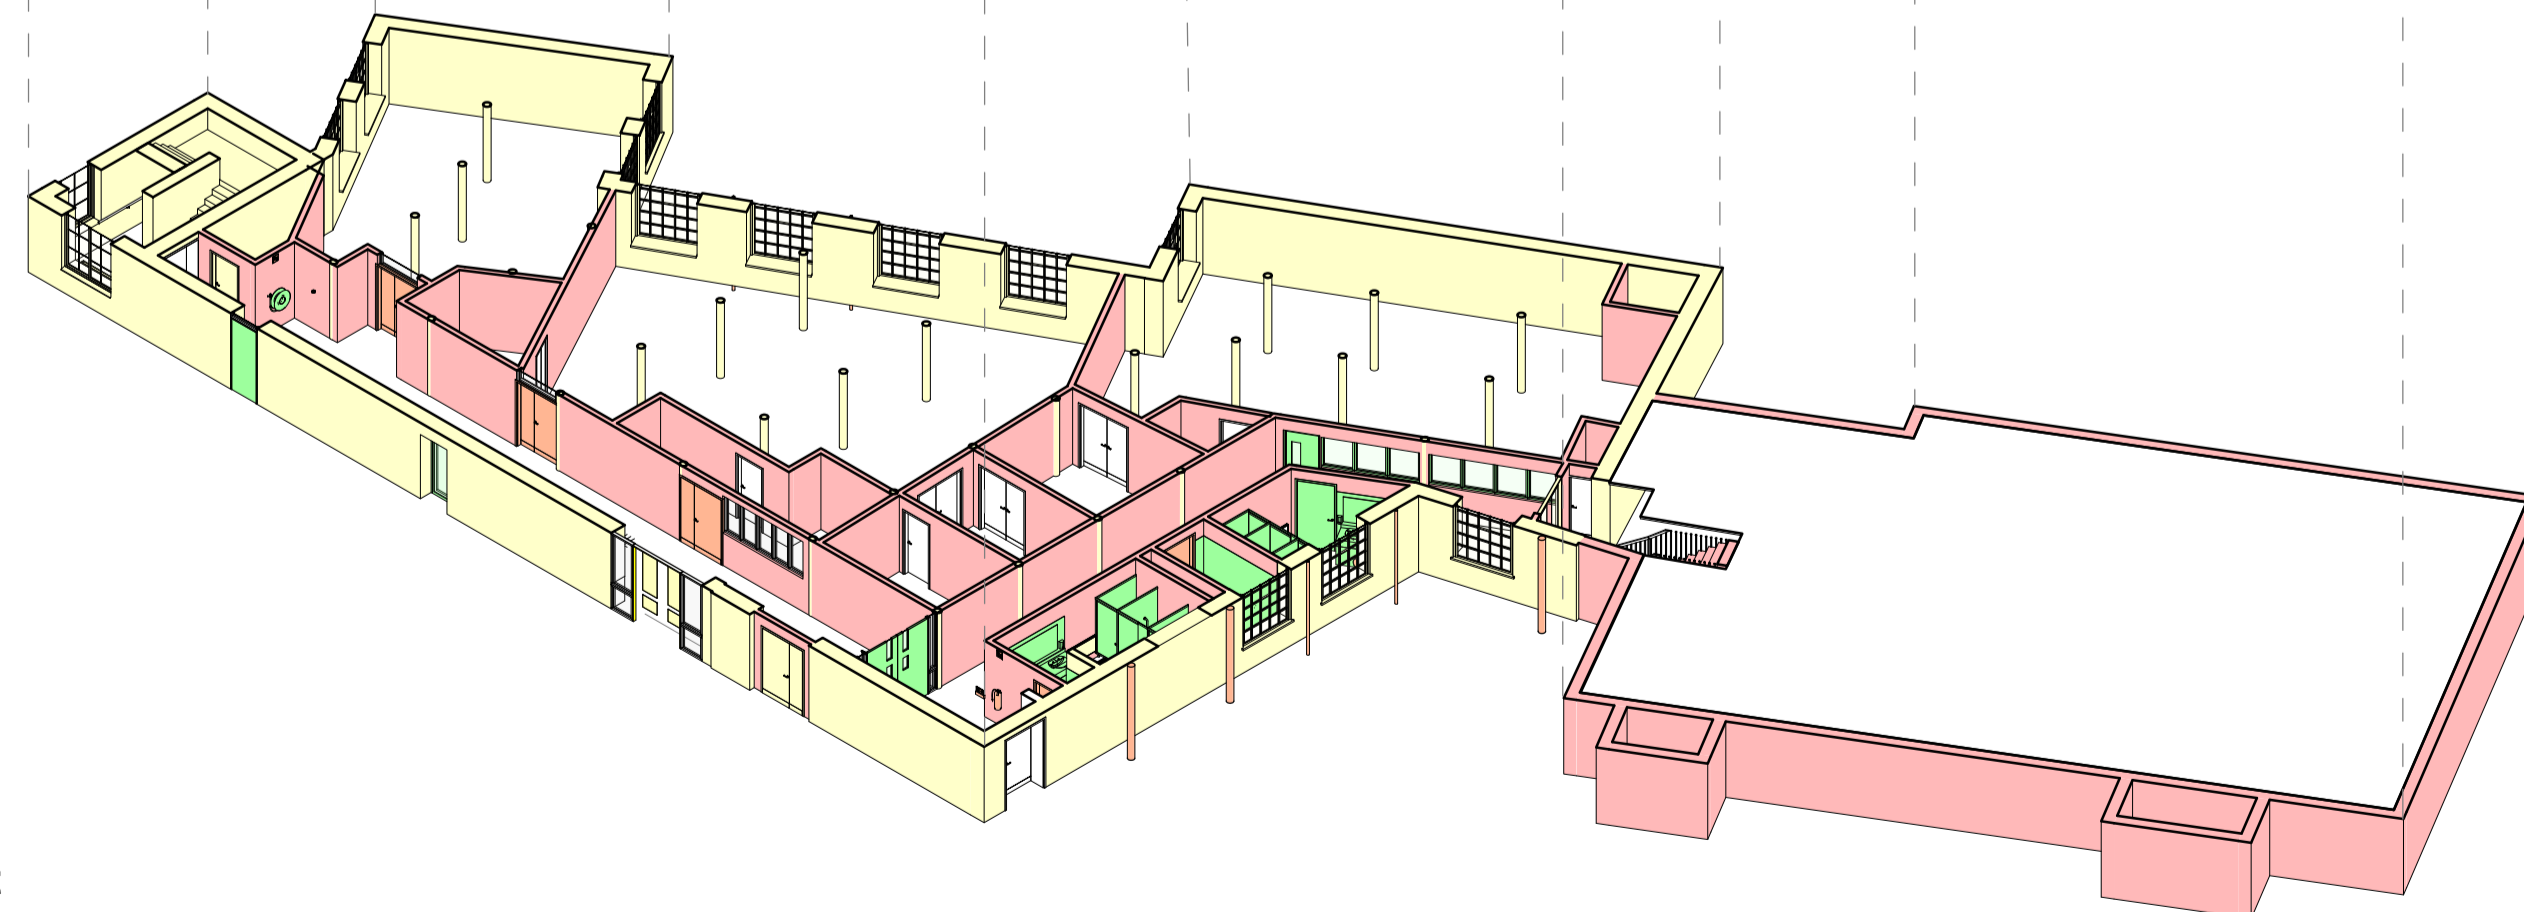
1 3D Roof Level Condition Report

Condition Evaluator	
	Good
	Average
	Requires Certified Inspection
	Bad

3D Condition Report  
Utilising the 3D model to highlight the condition of everything noted in the waste harvesting inventory.

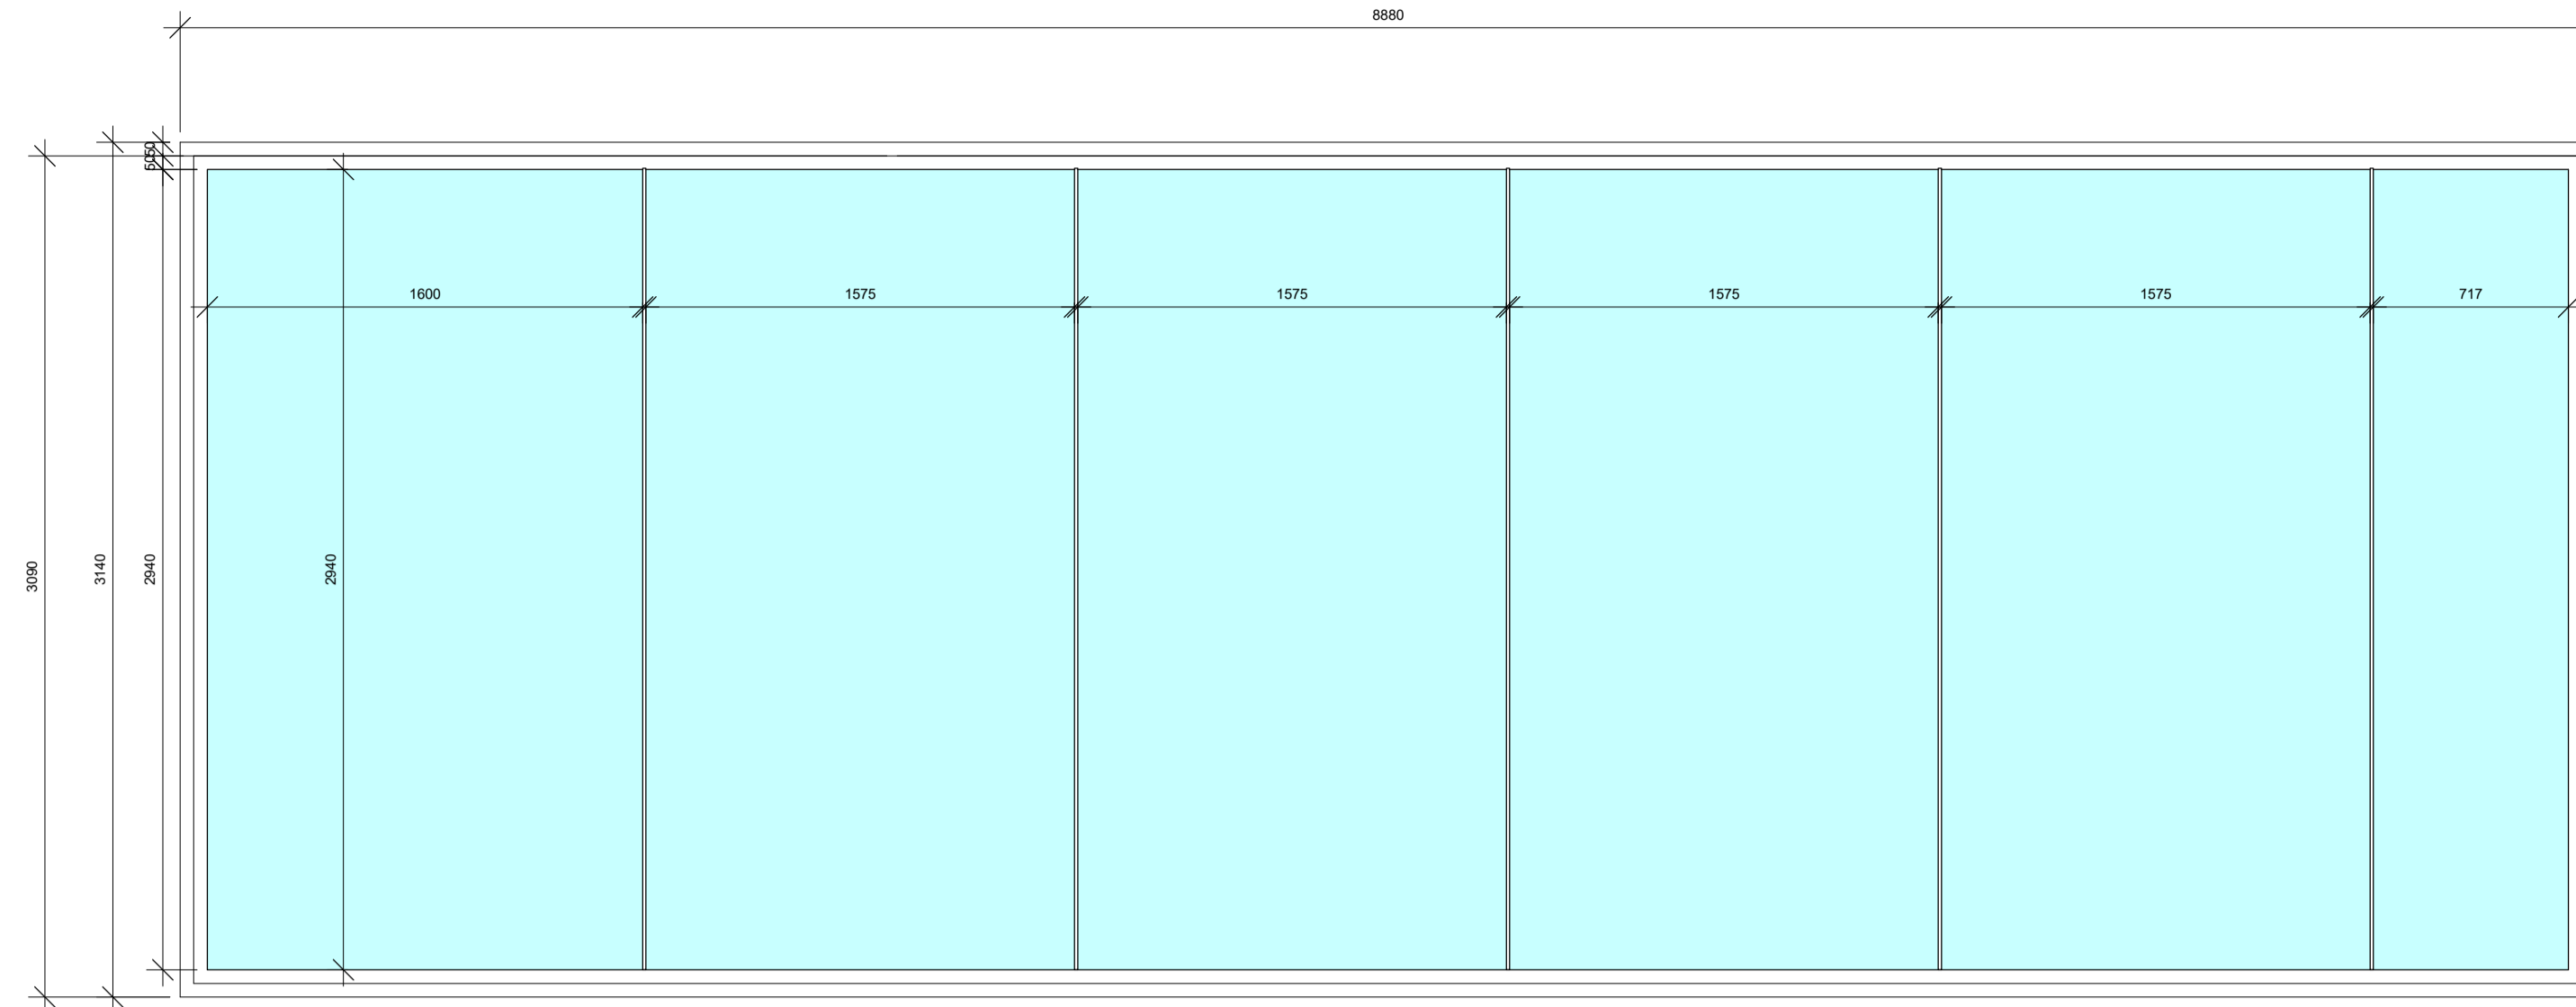
**1 WINDOW TYPE 11**  
SCALE: NTS

Window Type 11			
SEE WINDOW TYPE 11	FRAME	Domed Rooflight	
	FRAME MATERIAL	12mm Timber Frame Unknown finish	
	GLAZED AREA	21.1m <sup>2</sup>	
	ADDITIONAL INFORMATION (IF REQUIRED)		
Mark	Level	Description	Type
	Top of Roof		Window Type 11 8880 x 3120

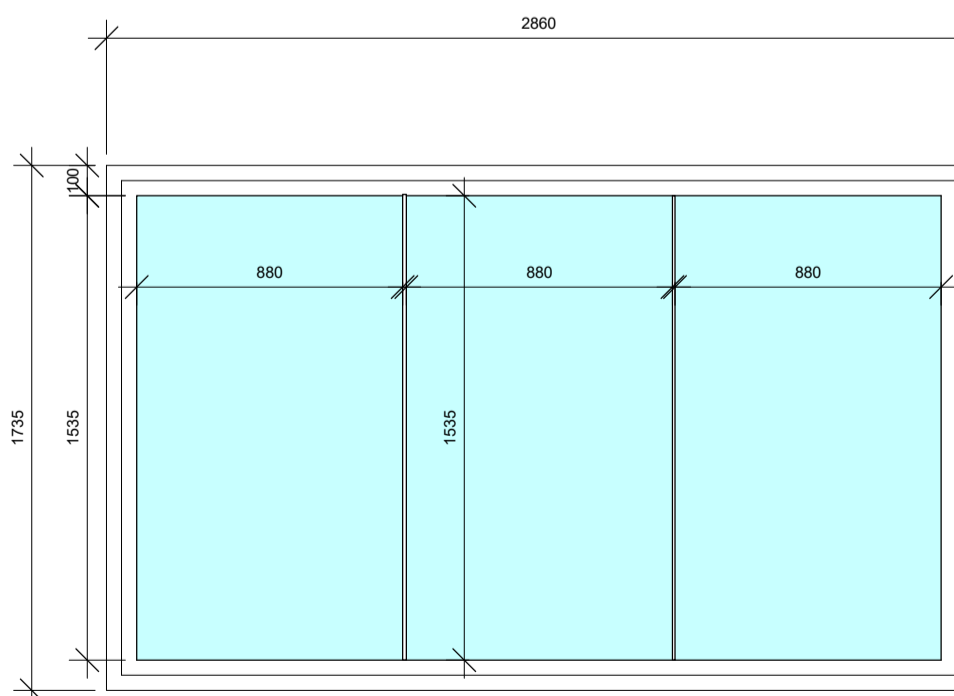
**3 WINDOW TYPE 13**  
SCALE: NTS

Window Type 13			
SEE WINDOW TYPE 13	FRAME	Domed Rooflight	
	FRAME MATERIAL	12mm Timber Frame Unknown finish	
	GLAZED AREA	1.35m <sup>2</sup>	
	ADDITIONAL INFORMATION (IF REQUIRED)		
Mark	Level	Description	Type
