No 158 Lisimore Road Crumlin County Dublin

The house chosen for this project is No 158 Lisimore Road in Crumlin and is one of a number of similar parlour / kitchen type cottage developments throughout Dublin, constructed circa 1940. The aim of this retrofit project is to improve the Building Energy Rating (BER) from its current rate of F to A2.

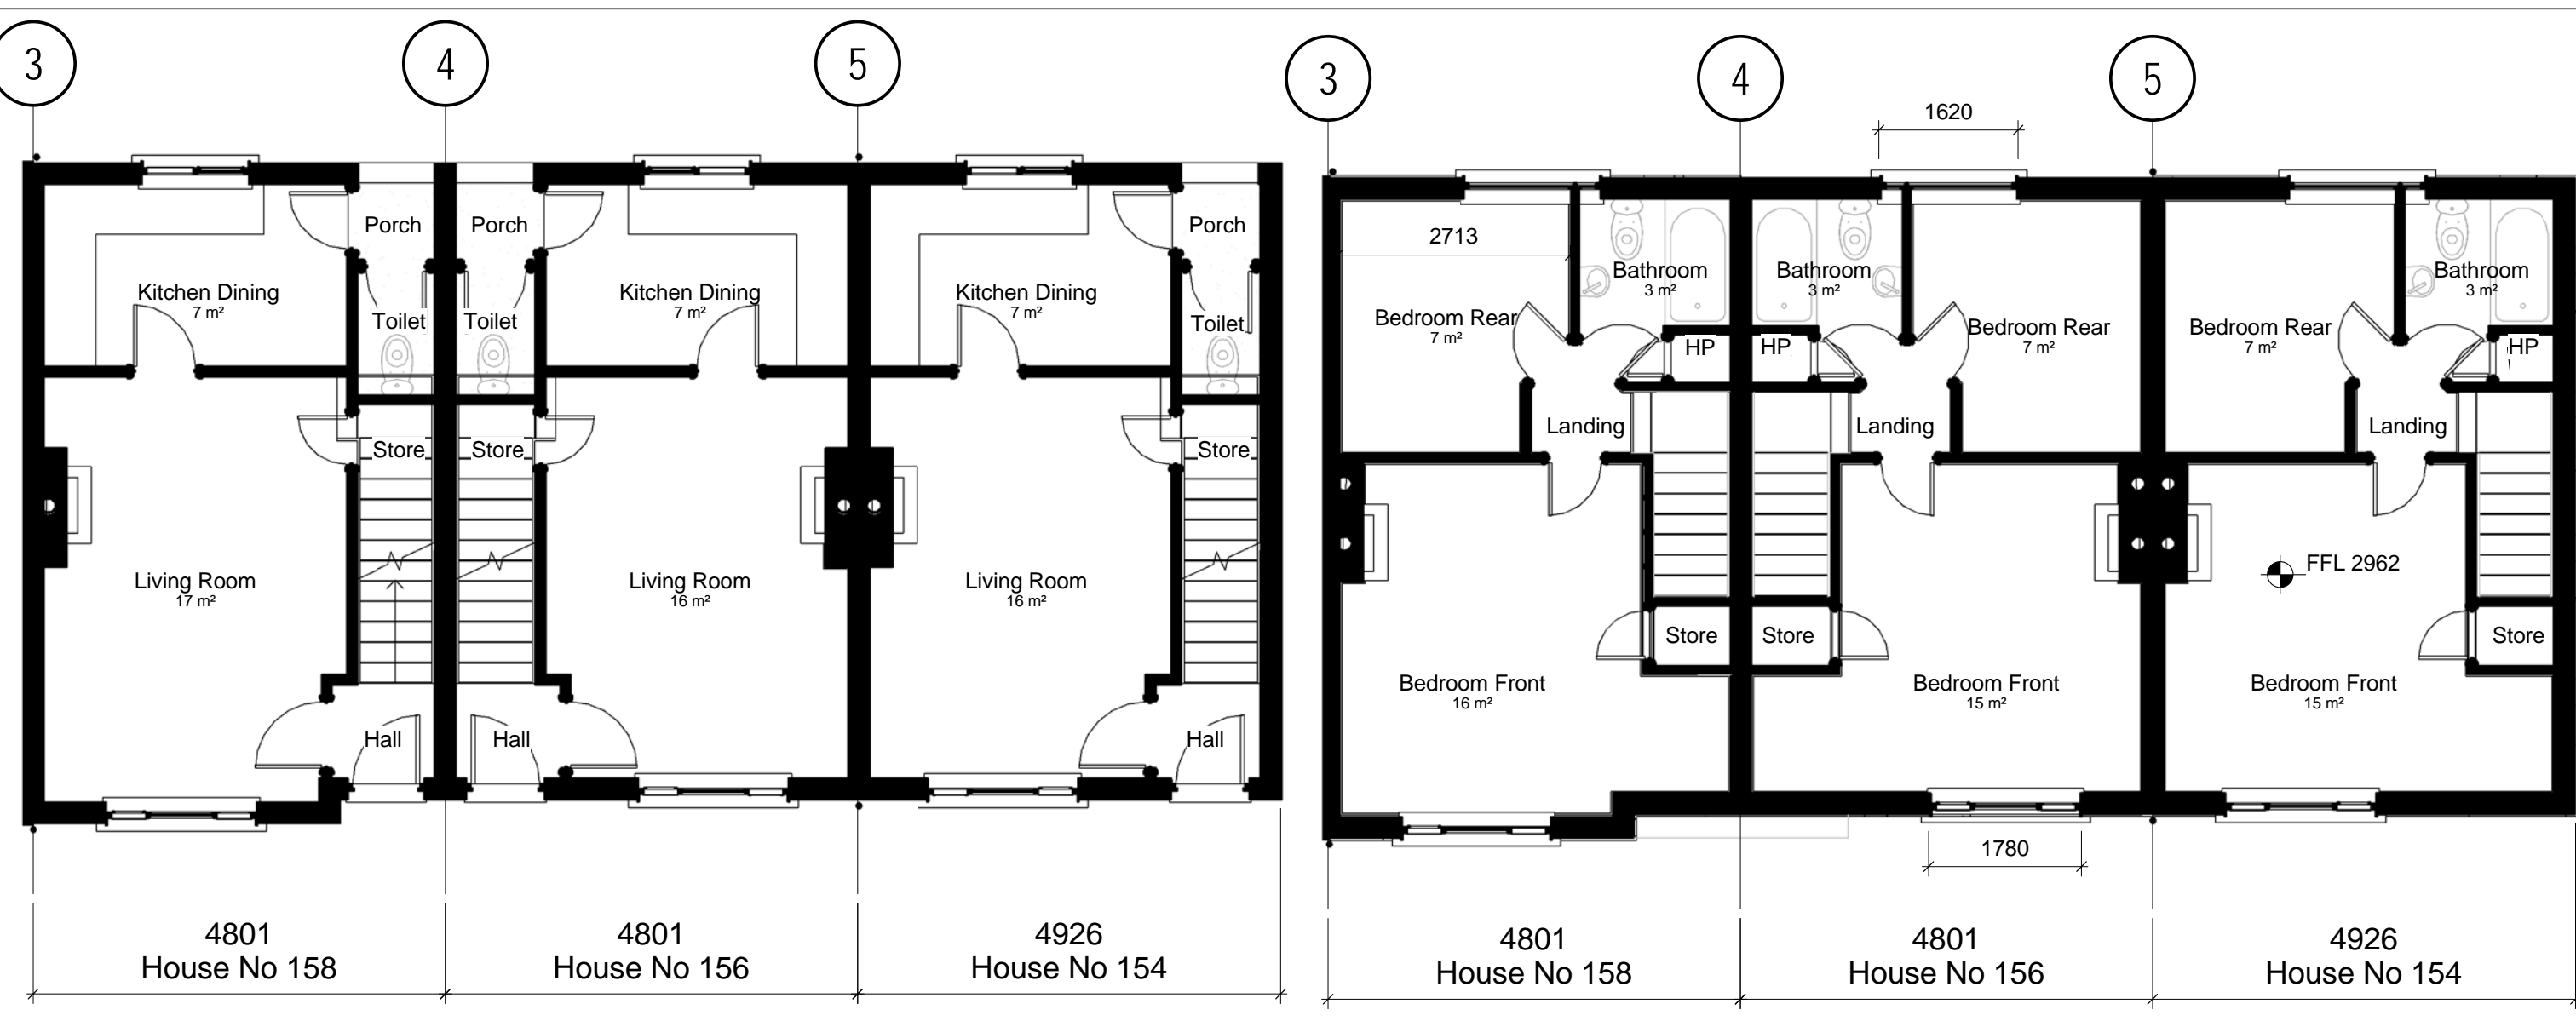
- Existing Building Fabric**
- Walls - 215mm / 90mm solid concrete
 - Ground Floor - Concrete
 - Ceiling - Plaster slab (no insulation)
 - Roof - Concrete roof tiles
 - Windows - Double glazed
 - No Insulation
- Existing Building Energy Rating**
- House No 154
 - House No 156
 - House No 158
